DELAWARE RIVER BASIN
YORK CREEK, PIKE COUNTY
PENNSYLVANIA

ELM LAKE DAM

PHASE I INSPECTION REPORT
NATIONAL DAM INSPECTION PROGRAM

NDI - PA 00397
PA DER 52 - 164

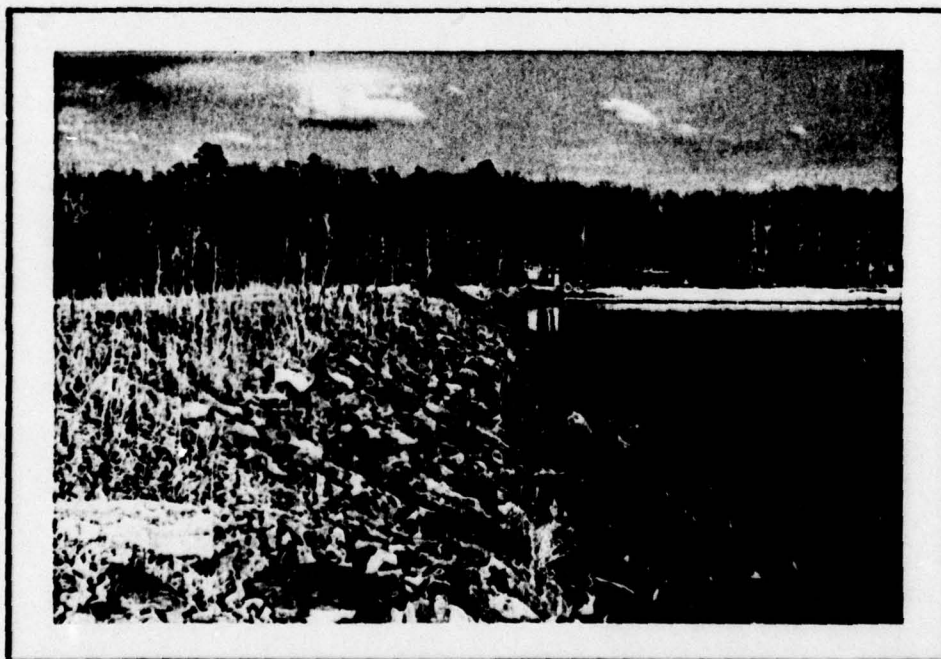
The riprap protection for the upstream slope of the embankment is poorly graded and sparse in many areas. The riprap on the upstream face should be supplemented, replaced and regraded where necessary.

The Riprap is inadequate; it
appears that it was randomly
dumped during construction.
Some minor failures may also have
occurred since construction.

*UPSTREAM FACE OF DAM
LOOKING TOWARDS RIGHT ABUTMENT*

2. The riprap on the upstream face should be supplemented, regraded and replaced where necessary to provide adequate protection against wave erosion. The riprap should be removed so that a crushed stone base may be placed beneath the riprap in any location where such a base does not exist.

Repair of the Riprap
is recommended where
required.

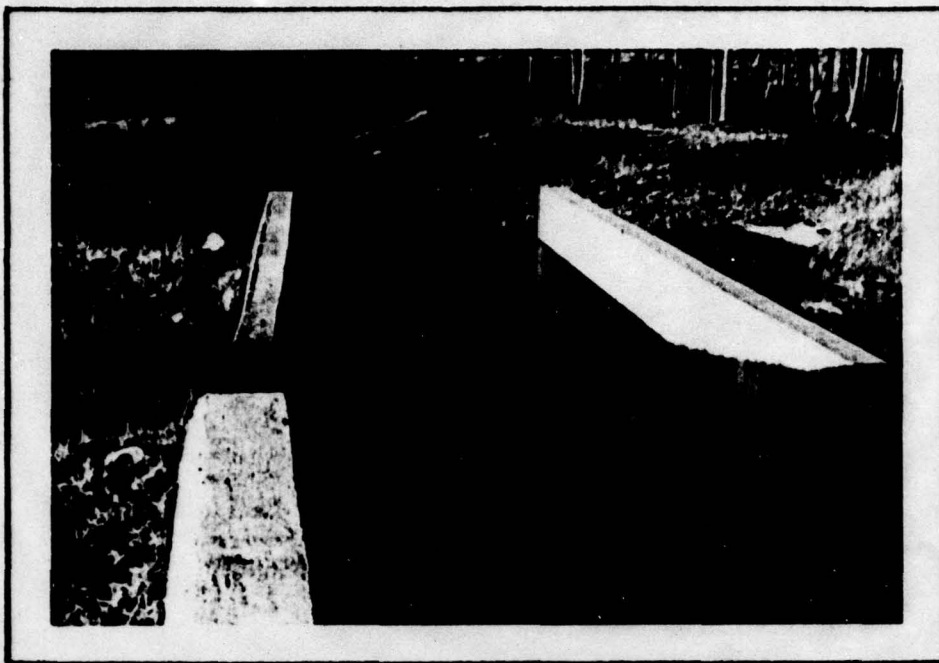
The drop spillway appears to be in good condition. The drop spillway outlet channel differed slightly from that shown on the drawings. According to the drawings, each training wall is to converge and then reduce the width of the channel by 2 feet along its 50-foot length. However, the right training wall is straight and the left training wall has an inward batter of 4 feet along its 50-foot length.

The sections of channel (Concrete slab, training walls, grouted riprap and ungrouted riprap sections) below the spillway appeared to be in good condition. The discharge channel empties directly into the valley and not the stream.

*SPILLWAY AND OUTLET CHANNEL
LOOKING FROM SPILLWAY CREST*

Continuation of the channel down to York Creek is recommended for proper drainage.

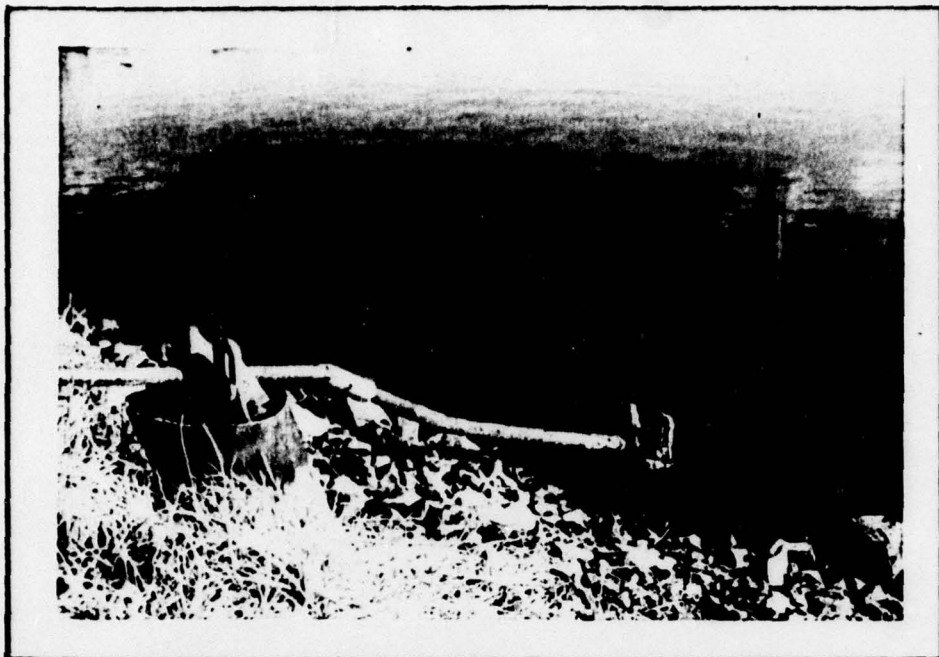
c. Appurtenant Structures. The reservoir drain system is inoperable. The stem leading to the sluice gate is bent, cracked, and rusted and the hoist mechanism is in very poor condition. Repairs to the stem had apparently been attempted since one section is welded, but the remainder of the stem is still in a state of disrepair. The outlet pipe is partially buried in mud and debris. A small amount of water is flowing from the toe drain outlets in the outlet structure.

*POORLY MAINTAINED HOIST STEM
OF THE RESERVOIR DRAIN SYSTEM*

1. Immediate repairs should be made on the reservoir drain system to provide for reservoir draw down. The outlet structure should be cleared of mud and debris to allow free flow from the outlet pipe.

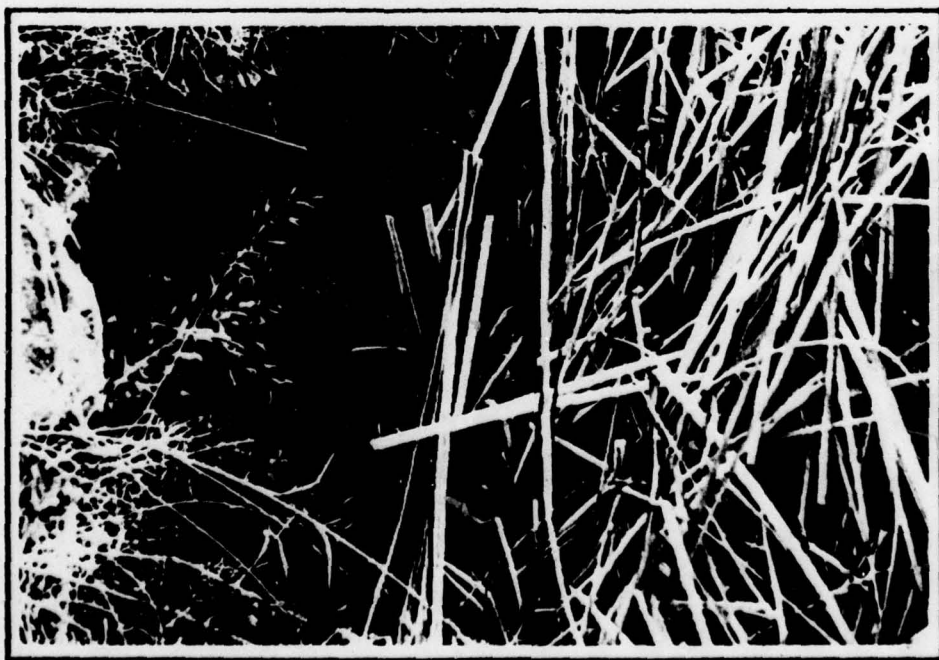
*PARTIALLY BURIED RESERVOIR
DRAIN OUTLET STRUCTURE*
